THE WOOLLEY PUBLIC HOUSE

**PROJECT NO: RC21020**

**NOTIFICATION  
and  
PLAN OF WORK  
WITH  
ASBESTOS  
AT  
The Wooley  
Colliery Road  
Darton  
Barnsley  
for  
Goldcrest Leisure  
York**

**MCP Environmental Services**  
**Asbestos Safety Audit**

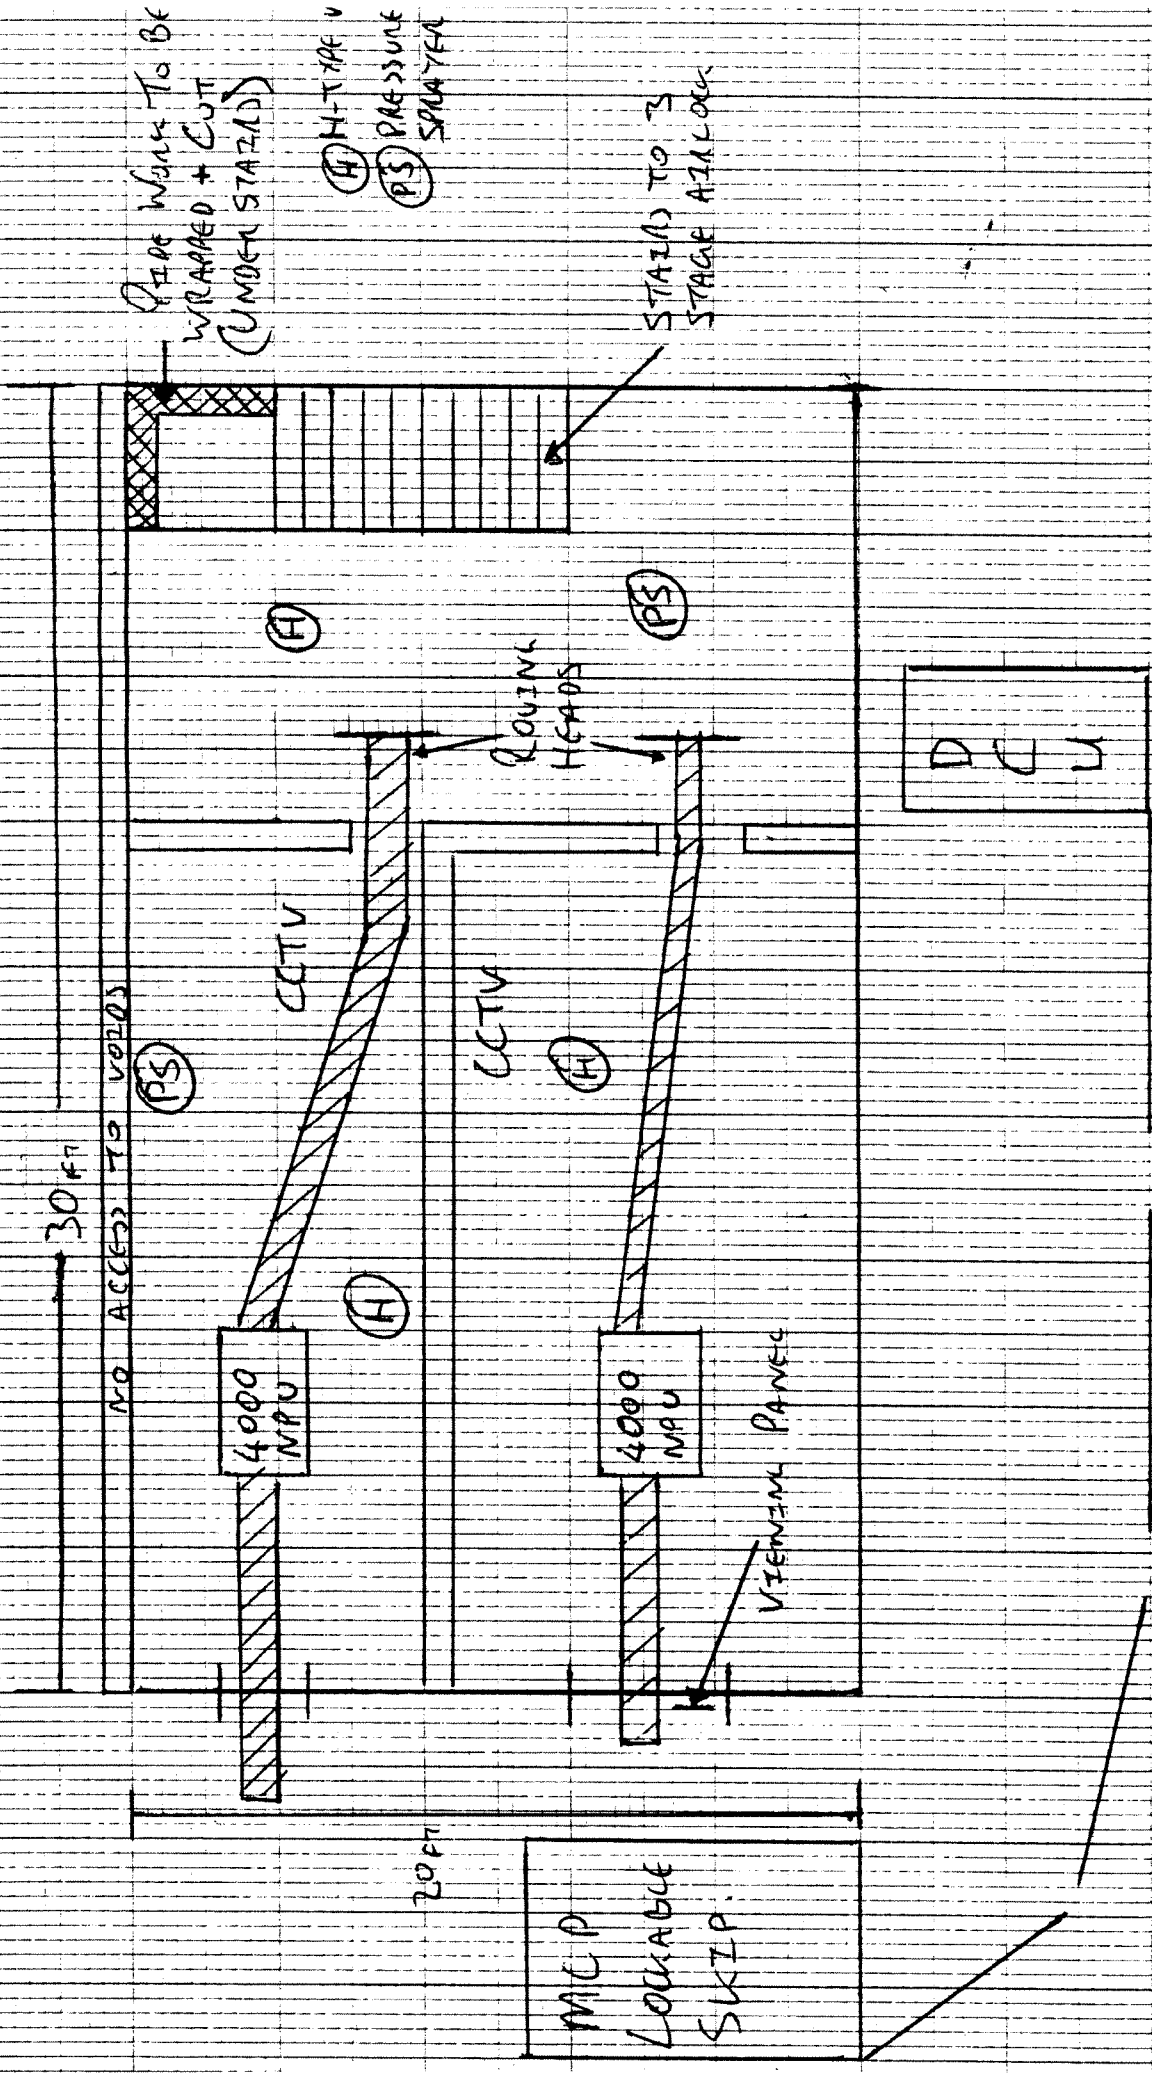
BASEMENT PLAN  
THE WOOLLEY PUBLIC HOUSE DARTON

PIPE WORK TO BE WRAPPED + CUT (UNDER STAIRS)  
 (H) H-TAPE U  
 (PS) PRESSURE SPRAYED
