## SCHEDULE 2 REPAIR NOTICE WORKS

## WORKS

## 2.0 THE ROOFS

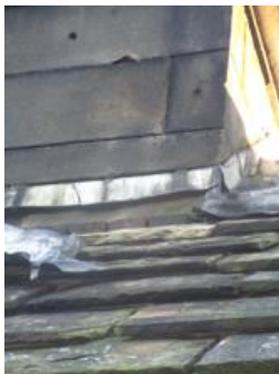
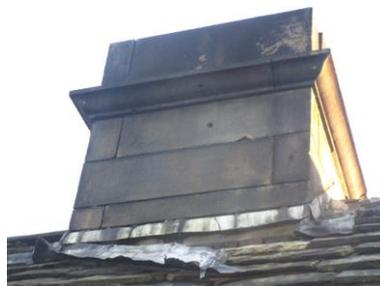
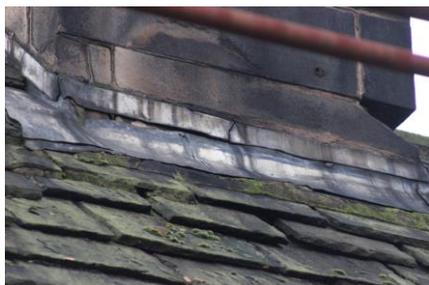
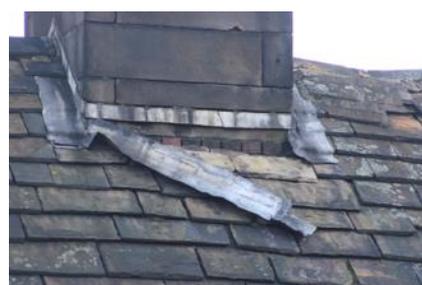
Chimney stack no. 1 has open pointing to all joints. Constructed from large stone sections with a smooth face. Top course above feature stone string course looks loose with each joint widening and open. Lead cover flashings have been fitted into saw cuts within face of stone. The lead cover flashings are in poor condition, split and torn, falling away from where they were installed on East and West sides of the ridge. North East corner of the chimney just above the cover flashing a top corner of the stone is missing.

All the stone ridge sections appear to be present and mortar bedded. However, the ridge line does undulate due to poor workmanship as sections have been re-bedded, particularly adjacent the chimney on the South side. Also poor bedding and workmanship to the South end towards gable no. 1 and North end towards gable no. 2. Open pointing to the majority of joints.

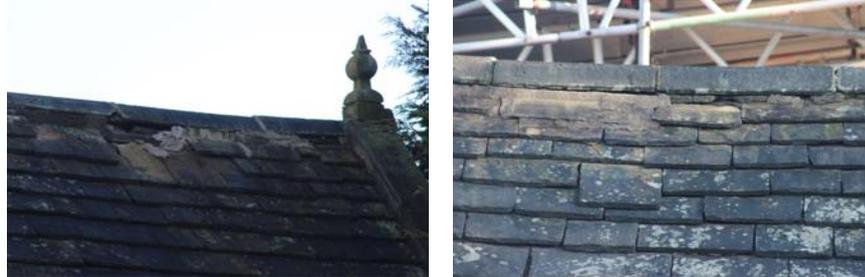
Stone water tabling to gable no. 1 has open pointing with heavy mortar bedding and flaunching against roof tiles, no indication of lead soakers or flashings present.

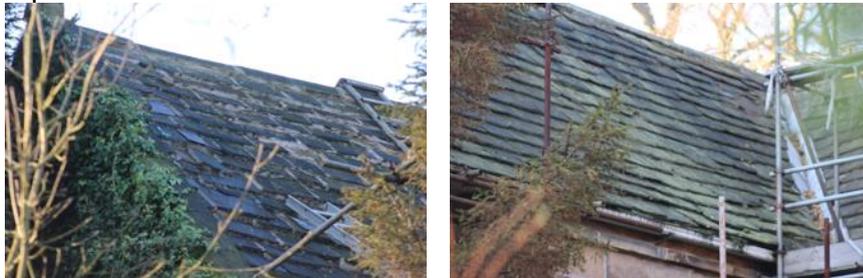
West facing side of roof A has a slight sag down from gable no. 2. Stone roof tiles are approximately 20-25mm thick and generally in good condition estimated 70% salvageable from visual inspection from the ground and ladder. There are locations where 1 or 2 tiles have slipped out of position. At ridge level to the south end of the roof there are roof tiles missing and poor quality repair works.

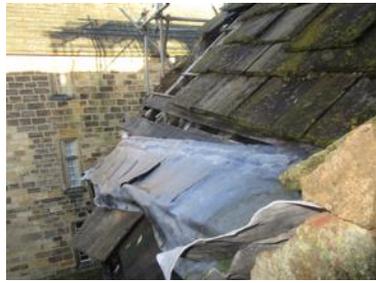
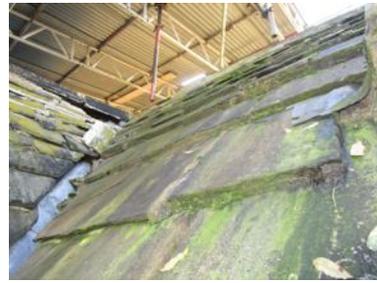
The roof over the full height entrance porch can only be estimated to be in a similar condition as the previously mentioned roof due to restricted access, however it was possible to see that the lead valley flashings were present. Stone tabling has open pointing and significant overhang to horizontal sections at eaves.

Roof B1: West side adjacent gable no. 3 area inspected from ladder and existing scaffold. The roof in this area is deteriorating badly and in very poor condition. Stone roof tiles removed in areas and covered with temporary sheeting. Both sides of the roof adjacent gable no. 3 are in poor condition with exposed rotten rafters and stone tiles missing, slipped and broken slate. Estimated that 40-30% salvageable where stone roof tiles are actually present for a reconstruction of the roofs.

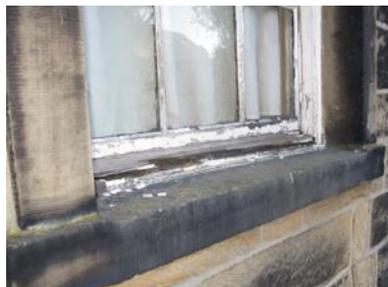
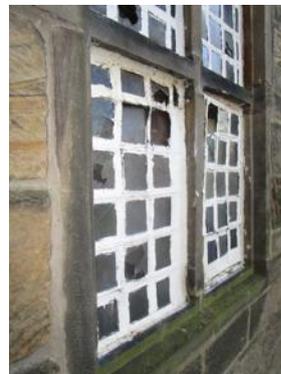
- 4.1 GFW1 to GFW4: Metal framed windows within stone jambs, cills and heads with stone mullions and transoms. Metal 'T' bar framework with window putty securing single glazed window panes. Framework painted white, showing rust in various locations. Fair to poor condition.
- 4.2 FFW1 to FFW5: Timber framed sash windows within stone jambs, cills and heads. Sash windows are single glazed with framework and beading painted white. Window FF/W4 has a pane of glass missing with a plywood replacement. The paint finish is in poor condition and as a result so are the timber frames and beading. Window cills are rotting, in particular window FF/W5.

1. FFW1 to FFW5: Overhaul timber windows and include for 3 no. splice cill repairs and 1 no. replacement of window quarry and full sand mastic replacement. E

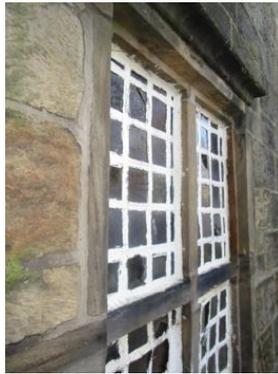
- 4.4 FFW6: Lead framed within stone jambs, cills and heads with stone mullions and transoms. Single glazed with small panes, framework heavily painted white. Broken and missing window quarries missing over all 4 lights. Lead framework is bellied, bowed and twisted throughout. Overall window in very poor condition.

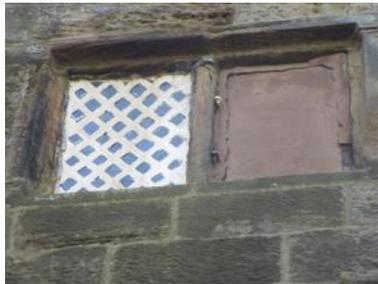
- 4.5 SFW1: Lead framed windows within stone jambs, cills and heads with a stone mullion. Single glazed windows with small quarries in a square formation, framework heavily painted white. Lead framework is bowed inwards. The second window has been replaced with a solid panel. Overall these windows are in very poor condition.

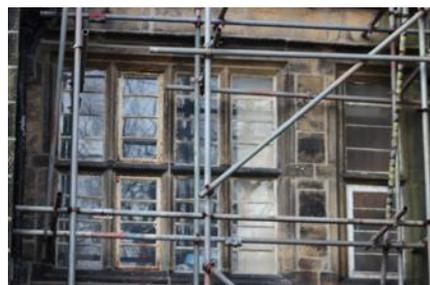
- 4.18 GFW15, 16 & 17 FFW19 to 25: Metal framed windows within stone jambs, cills and heads with stone mullions and transoms. Metal 'T' bar framework with window putty securing single glazed window panes. Framework painted white, showing rust in various locations. Windows FFW21 & FFW25 showing more rust and deterioration than others in this area with at least two broken panes. Overall these windows are in a poor condition.

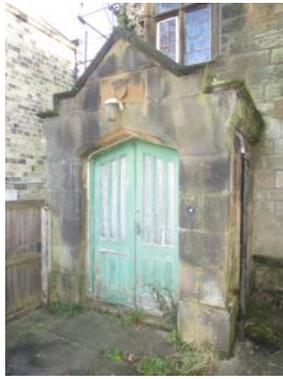
- 5.1 GFD1: Solid core timber panelled double doors with three single glazed vision panels to each door. Paint finish is fair to poor and missing in various places. Frame seal is not good. These doors are in poor condition.

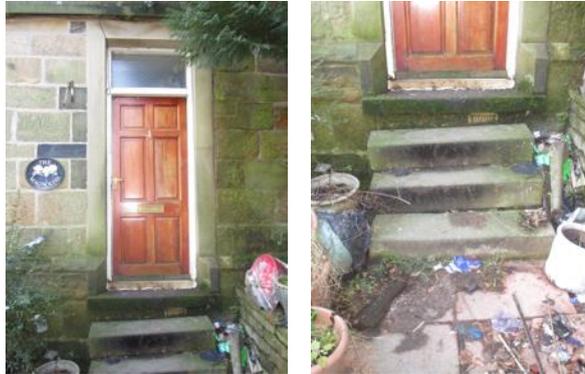
5.3 GFD3: Solid core timber panelled single door with obscure single glazed fan light over. Paint finish is fair to poor and missing in various places especially the threshold area. Concrete steps leading up to the door are un-even and need reconstructing. This door is in fairly poor condition.

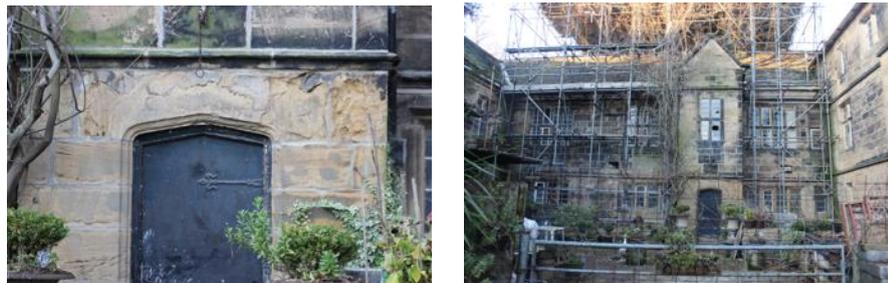
5.4 GFD4: Solid core timber single door. Paint finish is not good and missing in various places. Restricted access in this area didn't allow a close inspection but from a distance this door looks in fair condition.

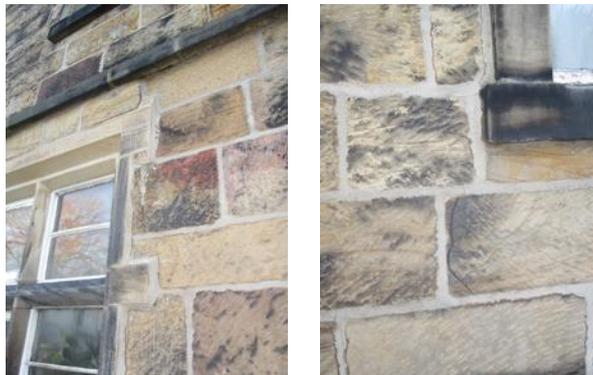
Eroded stone at high level below gutter string course adjacent gable 1. Line of external stone leaf is not straight and steps back adjacent window GFW3. Some external leaf disconnection is suspected as a consequence of the earlier fabric alterations – see historic photographs. No immediate action required but wall should be monitored for further movement.

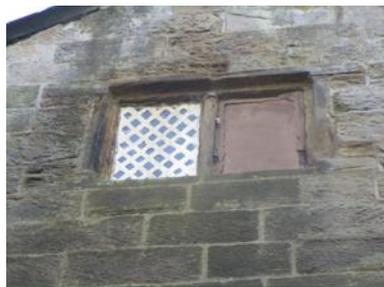
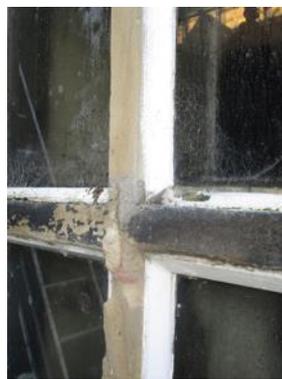
Facing stones above and adjacent window SFW1 are weather eroded with pitted face but considered satisfactory.

Window GFW5 Lower stone mullion and right hand stone transom are in poor condition, heavily eroded and unsightly with loss of definition and integrity. Replace stonework and refurbish windows

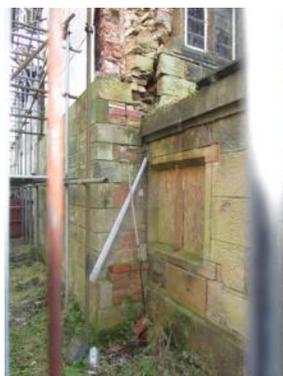
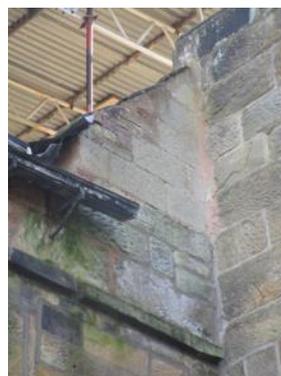
The west corner return at first floor level where it meets window FFW8 the external facing stonework and internal leaf and infill requires reconstruction. At low level the return towards the porch has brickwork infill between quoins, which is inappropriate and should be replaced in matching stonework. There is an anomaly at ground level with the alignment of the external fabric.

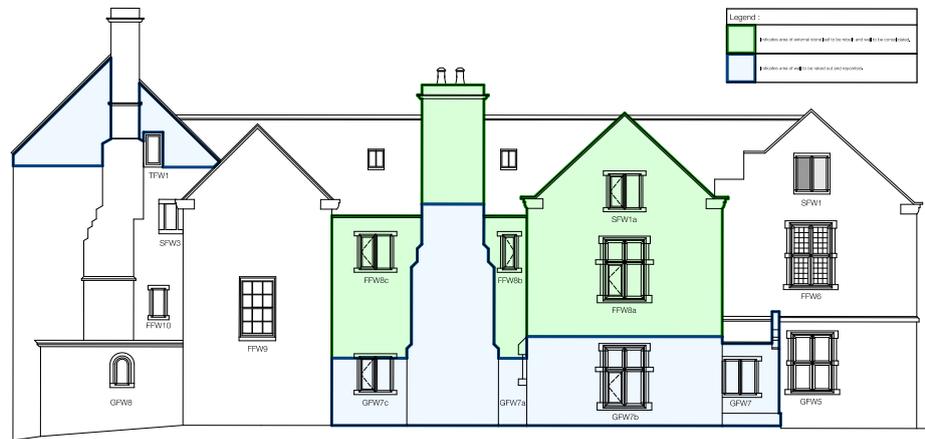
North Elevation

Drawing 1 below shows the extent of rebuilding still to be completed.

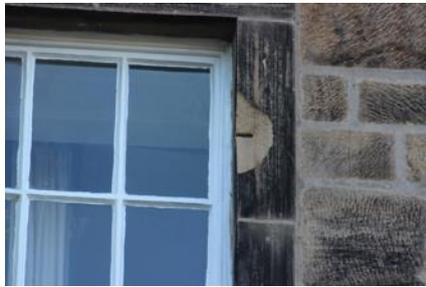
Window FFW12

Vast majority of the facing stonework is in good condition, flush pointed. Fine crack running up from head of window GFW9 to cill of window FFW11 mostly within the mortar joints but has cracked the corner off one facing stone. Upper section of the stone jamb to window FFW12 missing a significant piece of stone from the inner edge. To indent missing sections of stone and rake out and repoint cracked masonry joints in lime based mortar.

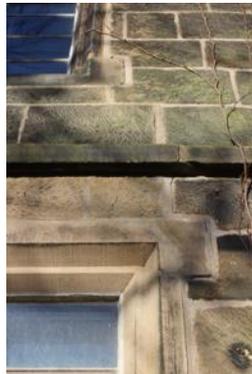
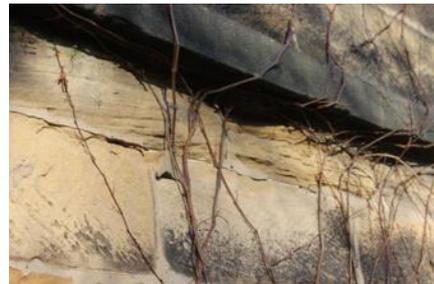
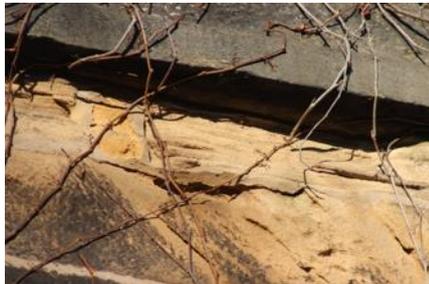
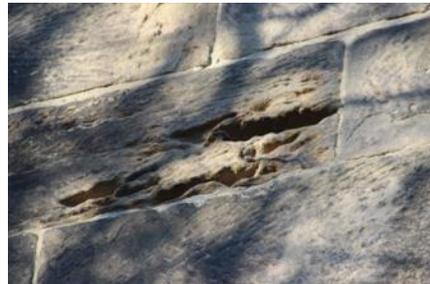
Fine crack running up the jamb past the head of window GFW13 to the jamb of window FFW17 mostly within the mortar joints but has cracked the corner off one facing stone. Potentially thermal movement. Rake out and repoint crack joint.

Stone jamb damaged in top corner to window SFW10.

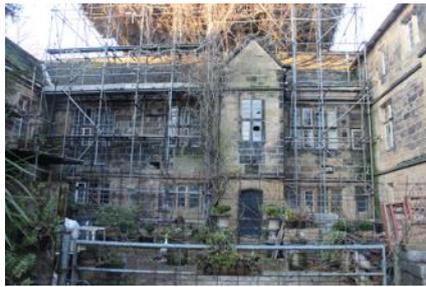
There are a few stones showing weather eroded damage to the face sporadically positioned around the elevation. The erosion is relatively minor and should be monitored long term as the stone does not appear to be currently attributing to water ingress.

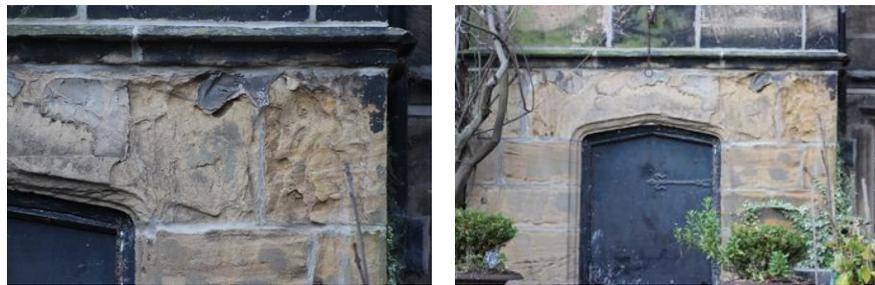
The face of stone lintel over door GFD4 is eroded with some loss of definition. The lintel has received mortar repairs which are now failing. It would be desirable to carry out some stone indent and mortar repairs on this feature entrance lintel.

Iron lamp bracket is in poor condition and needs a full refurbishment. Lower string course over windows has wide cement rich pointing which is inappropriate and needs removing and repointing in a lime based mortar.
