## SCHEDULE 2 REPAIR NOTICE WORKS

## WORKS

## 2.0 THE ROOFS

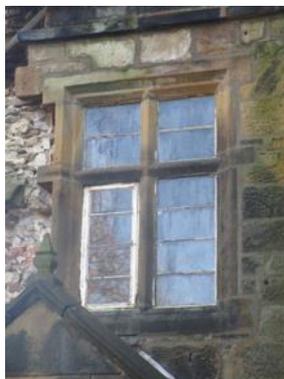
- 4.9 FFW9 & SFW2: Timber framed sash windows within stone jambs, cills and heads. Single glazed with framework and beading painted white. Recently painted. Overall these windows are in a fair condition.

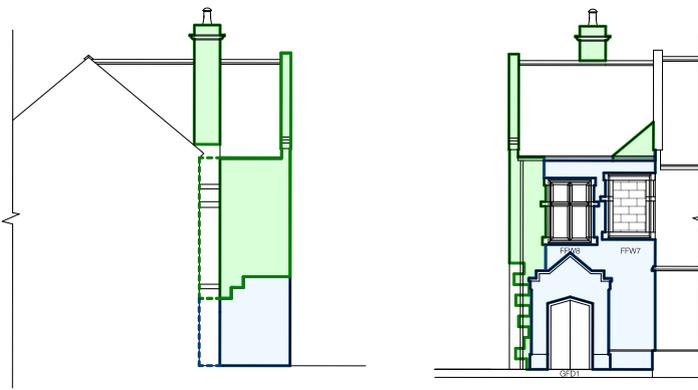
East/West of North Elevation

Between gables nos. 3 and 4 there is a temporary blockwork wall built with restraining pier to height of 6 metres built to provide security and weather protection.
